SPOONWOOD POND DAM

NH 00338

**PHASE I INSPECTION REPORT
NATIONAL DAM INSPECTION PROGRAM**

Inventory No.: NH 00338
NHWRB No.: 116.03
Name of Dam: SPOONWOOD POND
Town: Nelson
County and State: Cheshire County, New Hampshire
Stream: Nubanusit Brook, Tributary to Contoocook River
Date of Inspection: 18 July 1978

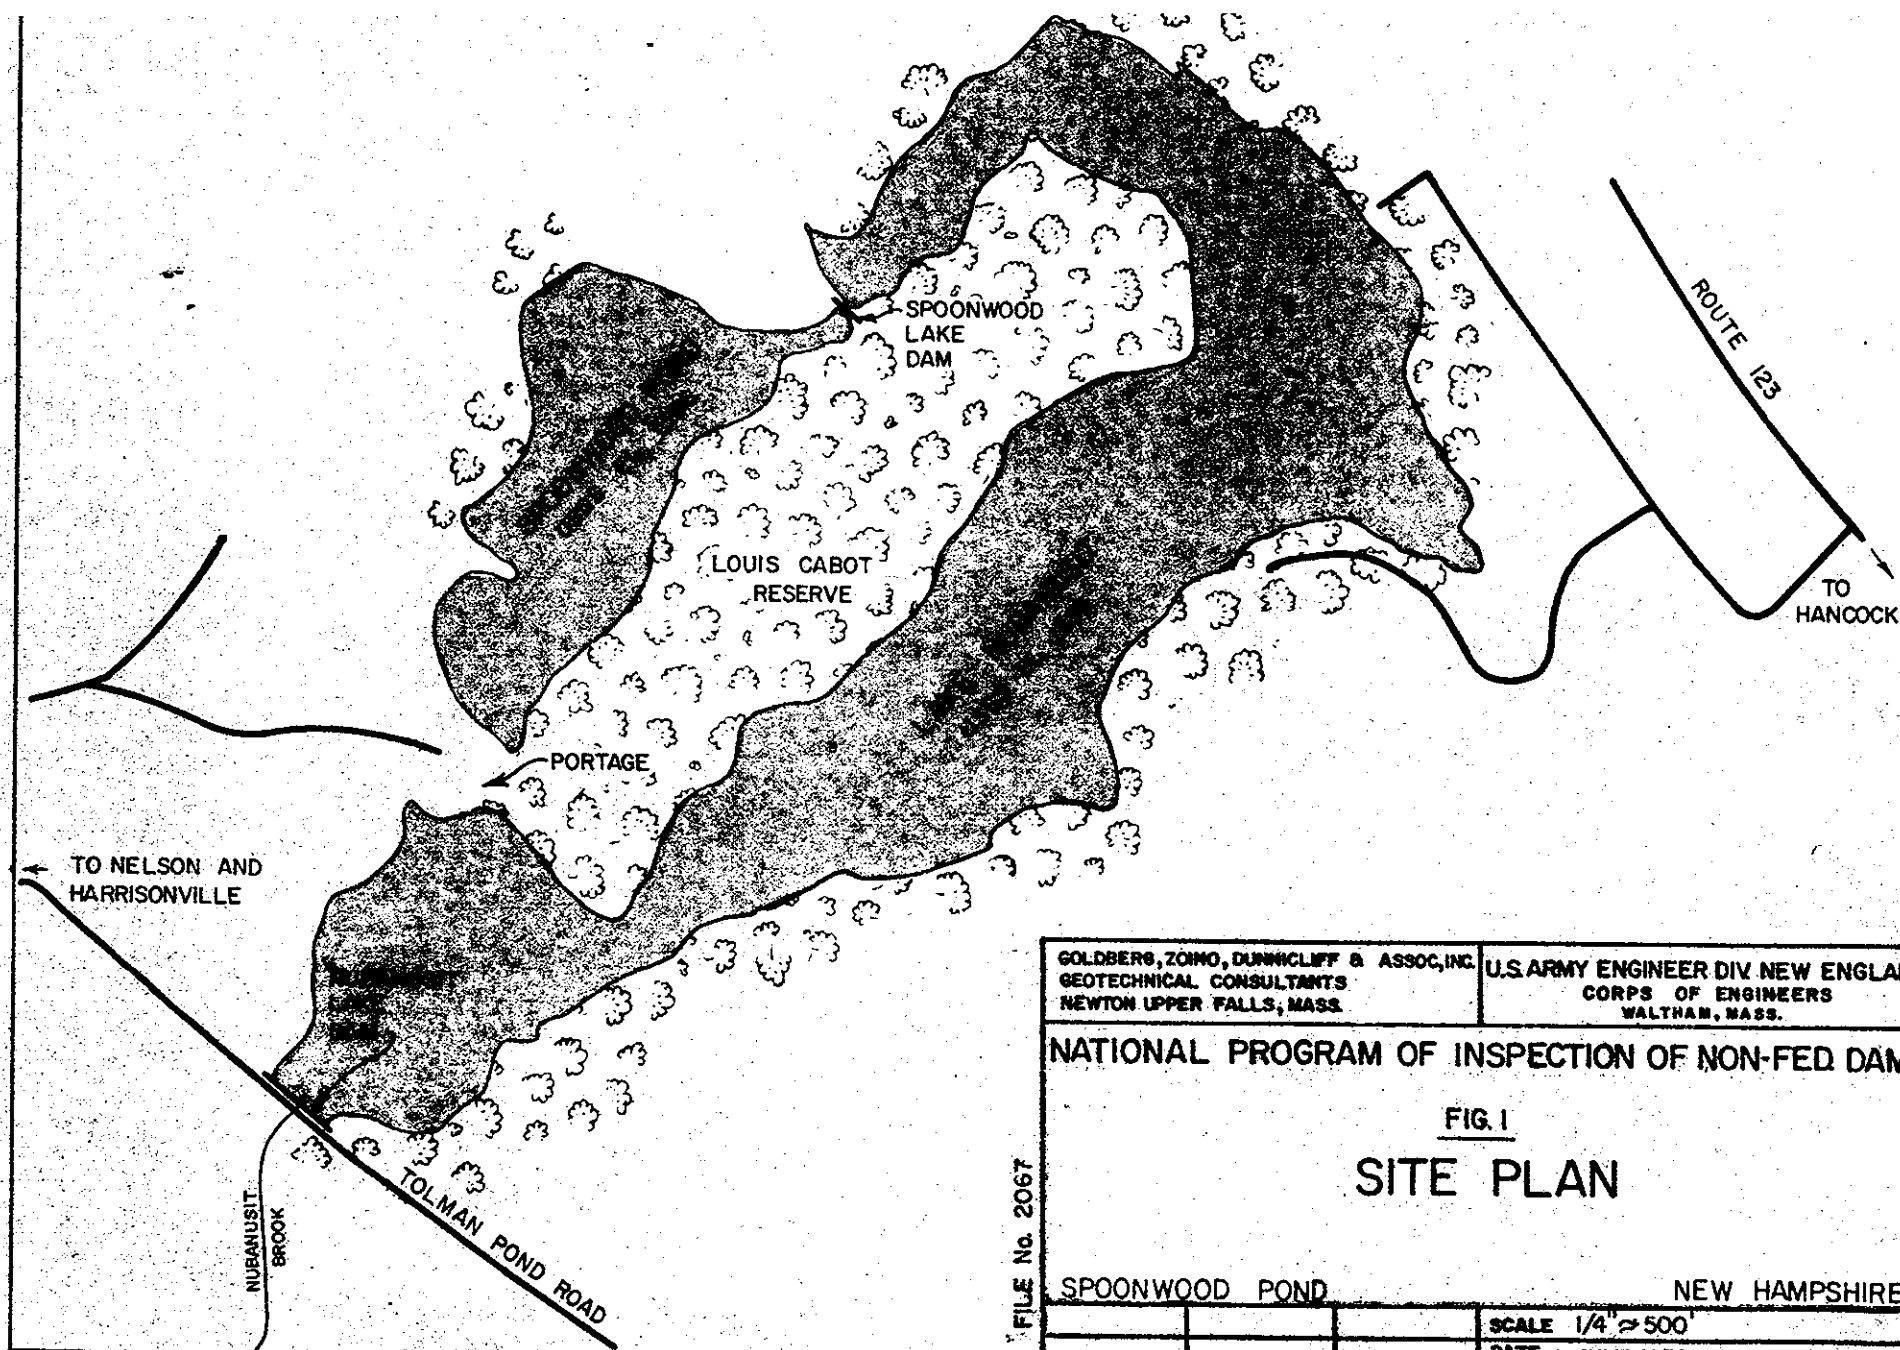
FIG. 1

The dam lies between Spoonwood Pond and Nubanusit Lake, approximately 1.8 miles northeast of the Nubanusit dam. Nubanusit Brook drains through a series of lakes, ponds and reservoirs to the Contoocook River, a tributary of the Merrimack. The site is only accessible by boat, with the Hancock public landing off Route 123 providing the nearest launching point. The portion of the USGS Monadnock, New Hampshire quadrangle presented previously shows this locus. Figure 1 of Appendix B presents a detail of the site developed from a town plot plan.

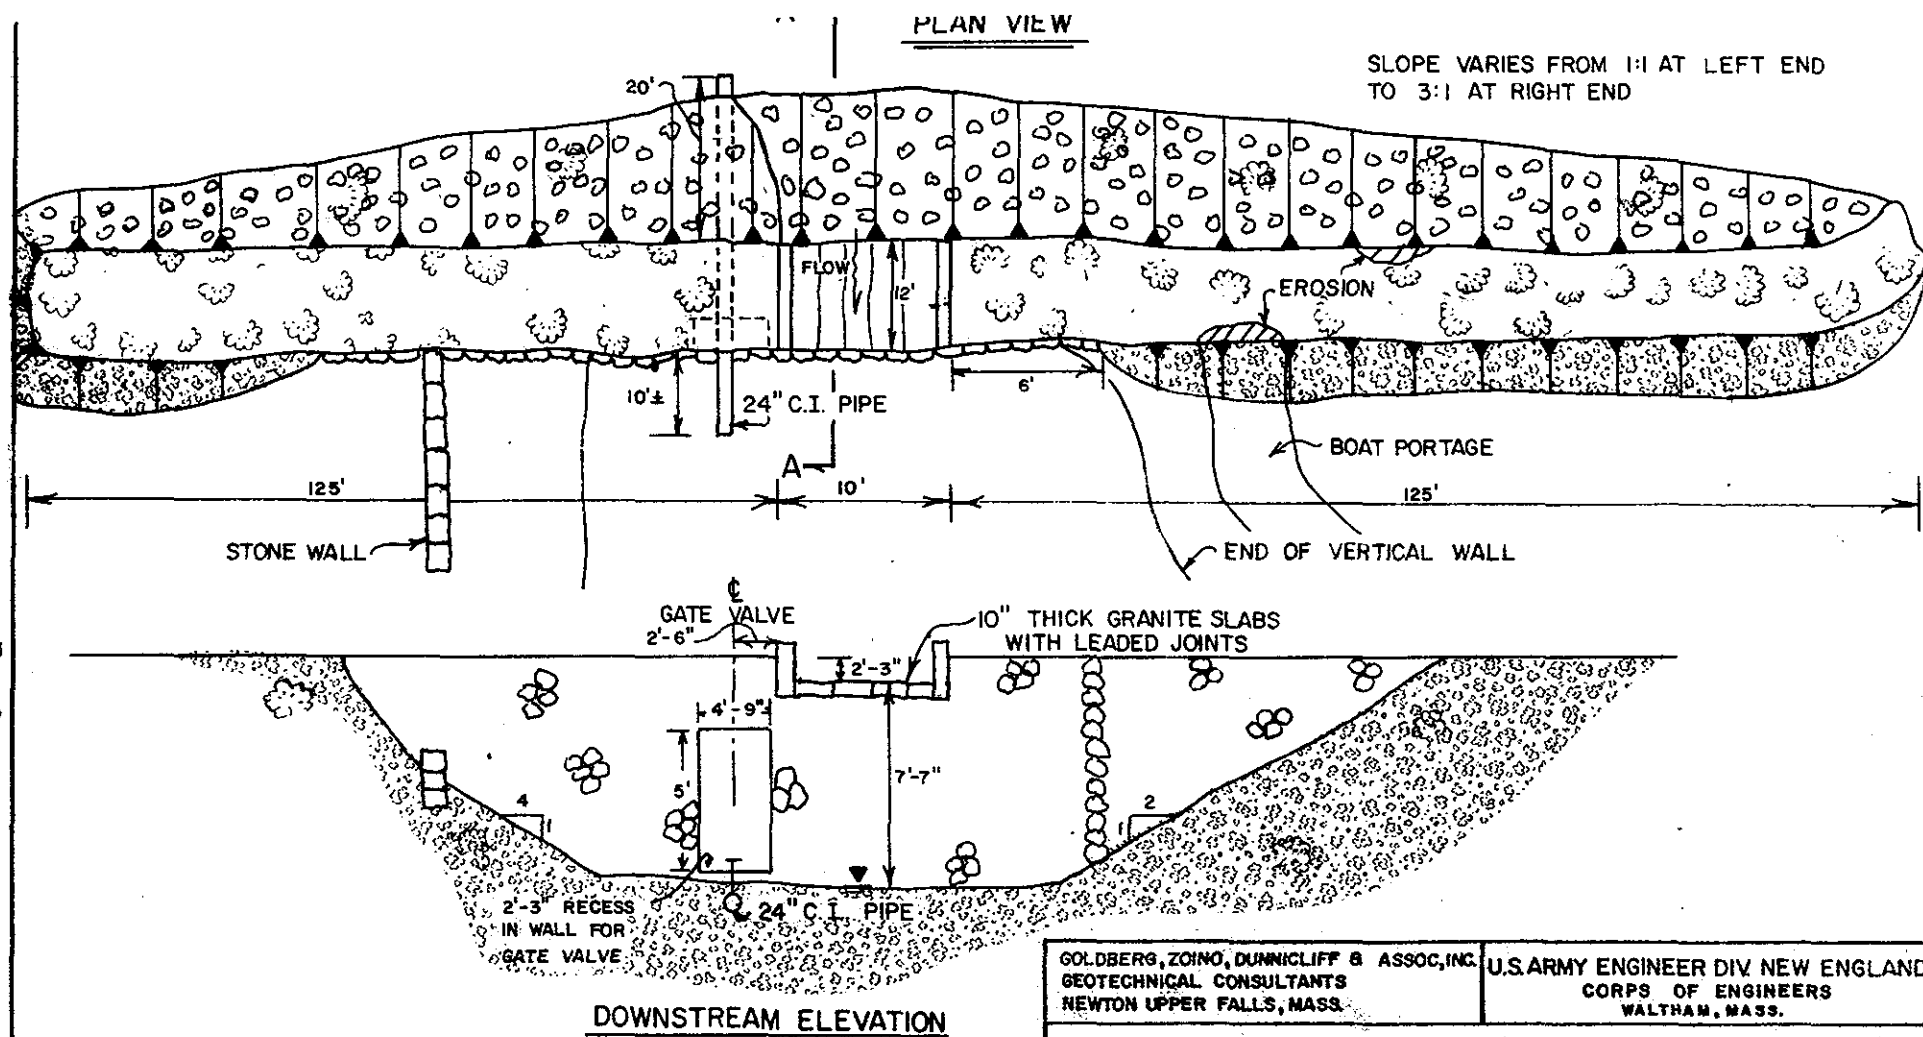
FIG. 2

The dam consists of a 280 foot long earth embankment with a maximum height of approximately 12 feet (Figs. 2 and 3). The embankment includes a 10 foot long spillway constructed of granite slabs and a 24-inch diameter cast iron pipe with gate valve (Fig. 3). The downstream side of the dam near the spillway and cast iron pipe consists of a vertical wall of natural, unmortared stone. The dam has some riprap on both the upstream and downstream slopes.

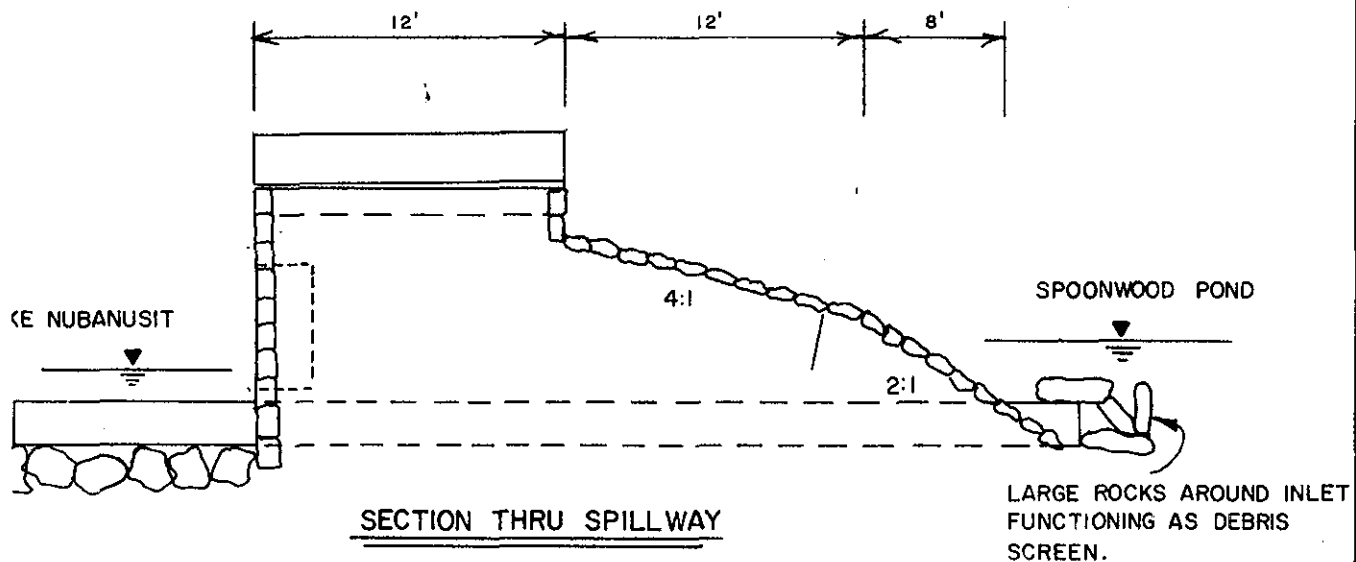
NOTE: SPOONWOOD POND DRAWDOWN
DURING TIME OF INSPECTION.
